**TECHNICAL BULLETIN 19:  
OAK RIDGE NATIONAL LABORATORY HOT BOX TEST RESULTS**

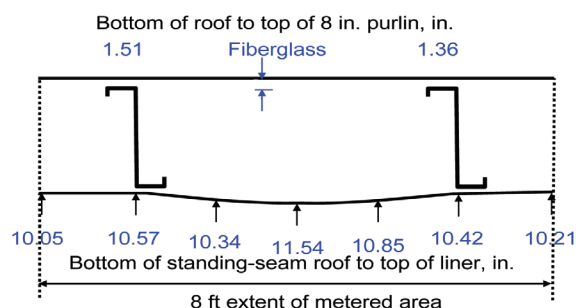
Fig. 4 Results of Pin Probe Measurements for the Simple Saver Configurations

At the conclusion of each test, before the test section was moved out of the LSCS, holes were drilled through the roof panels to admit a pin probe. It was used to determine depth from the bottom of the roof panels to the top of the liner or purlins. Eight holes were drilled parallel to the purlins at each location shown in Fig. 4. Each set was two holes in flat parts of each of the four roof panels within the vertical projection of the metered area. The numbers in Fig. 4 are the average of the eight measurements at each location for the fiberglass insulated Simple Saver configuration. The results are added to Fig. 4. It is assumed that the entire cavity was filled by the fiberglass insulation since it was free to expand.

Saver configuration, the insulation is severely compressed between the roof panels and the liner. The average gap from the roof to the purlins is 1.43 in. for the R-30 Simple Saver and 1.66 in. for the R-19 fiberglass draped over the purlins. The Simple Saver with fiberglass has an R-11 blanket between the clips and purlins. The draped R-19 fiberglass is between the clips and purlins. Therefore, the average gaps of 1.43 in. and 1.66 in., respectively, are also reasonable.

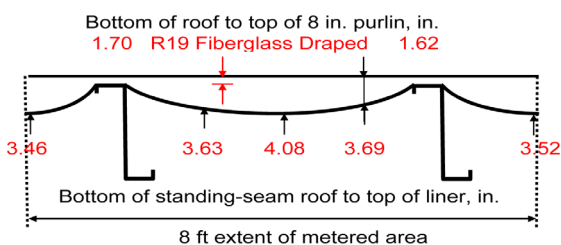
Fig. 5 Results of Pin Probe Measurements for the non-Simple Saver Configurations

Figure 5 shows the depth from the bottom of the roof panels to the top of the liner for the “over the purlin” configuration. Again, eight holes were drilled parallel to the purlins at each location shown in Fig. 5, with two of each set in flat parts of each of the four roof panels in the metered area. The numbers in Fig. 5 are the average of the eight measurements at each location for this configuration with fiberglass insulation. Unlike in the fiberglass-insulated Simple
